Appendix 3. Carrboro Stream Sites, April-June 2013

Bolin Creek sites are numbered from most upstream (Site 1) to most downstream (Site 4). Samples from Bolin Creek and Morgan Creek were collected in June 2013; tributary sites were sampled in April 2013.

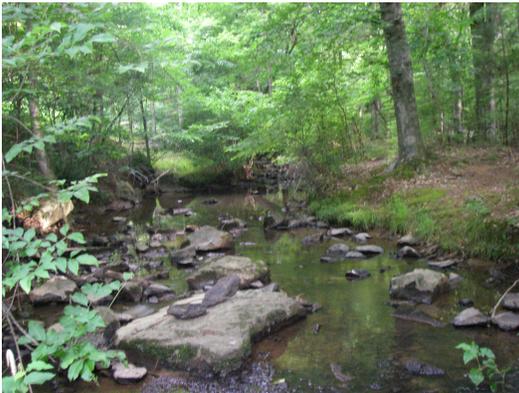
Bolin Creek Site 1, June 2012.

Bolin Creek 1. Site 1 was located upstream of the Winmore development, near the power line crossing. This site drains a largely rural and residential landscape; it is intended as a control site for the higher density residential areas further downstream. This portion of the stream may go completely dry during droughts.

This part of Bolin Creek averaged about 4-5 meters wide, with a substrate mainly composed of gravel and rubble. Both the substrate composition and the width, however, were highly variable. There were no significant habitat problems in this section of Bolin Creek.

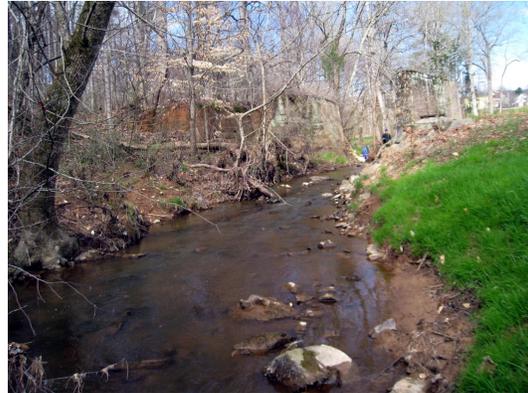
Bolin Creek Site 2, March 2010.

Bolin Creek 2. Site 2 is located downstream of the Winmore development at SR 1777. There is private residence on one side of the stream that lacks a buffer zone. Consequently, there is significant bank erosion on one side of the stream.

Habitat problems included fewer riffles, bank erosion, lack of a buffer on one side and a decrease in habitat diversity. A beaver dam was observed slightly upstream of this site.

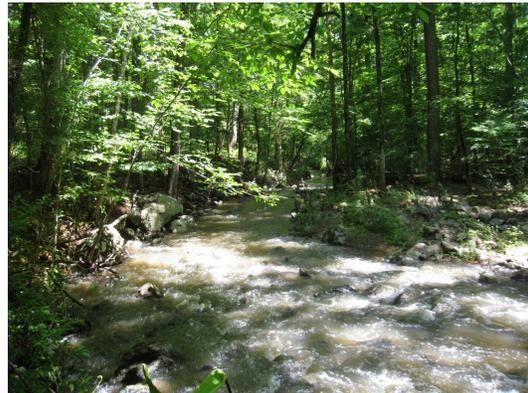
Bolin Creek Site 3, June 2013.

There are no significant habitat problems in this portion of the stream, but there was a lack of good bank habitat.

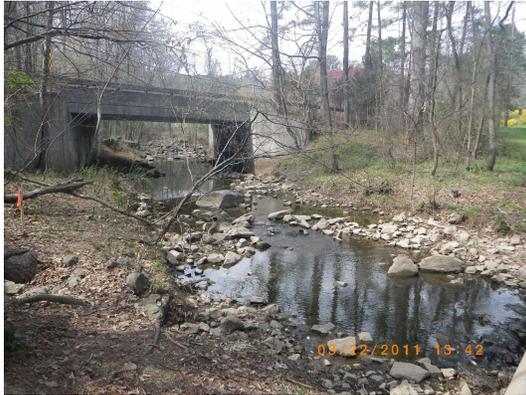
Bolin Creek Site 4, March 2011.

This portion of Bolin Creek is similar to the site on Estes Drive, having good rocky substrate. Attached filamentous algae was very abundant at the Village Drive site in March 2011, but was not a problem in 2012 or 2013.

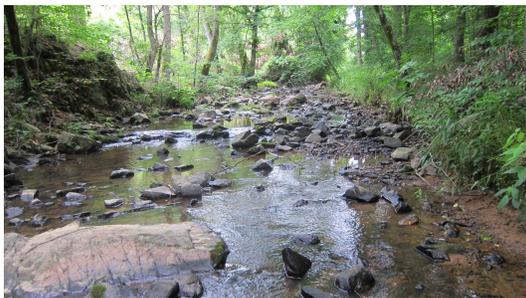
Morgan Creek, NC 54, June 2012.

Morgan Creek at NC 54. Morgan Creek was chosen as a reference site, although this stream had also been affected by droughts. Prior surveys by the NC Division of Water Quality often produced a Good or Excellent bioclassification for this site, although it has only been rated as Good-Fair in the last two years.

This catchment has a largely rural character, with some minor impacts from nonpoint source runoff. Habitat quality, stream width and substrate composition are similar to Bolin Creek, but with less residential land use. Residential land use, however, has

been increasing in the Morgan Creek catchment in recent years.

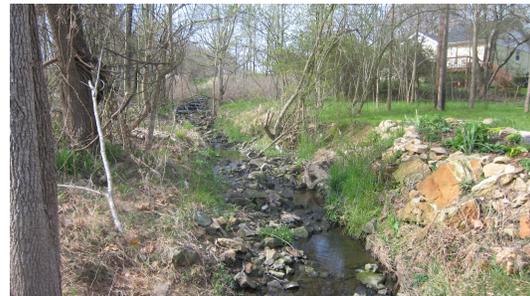
UT Tanyard Branch, April 2013.

UT Tanyard Branch at Baldwin Park. This stream is on the border between Chapel Hill and Carrboro; it drains a highly urban watershed that includes parts of downtown Carrboro and a highly developed residential area.

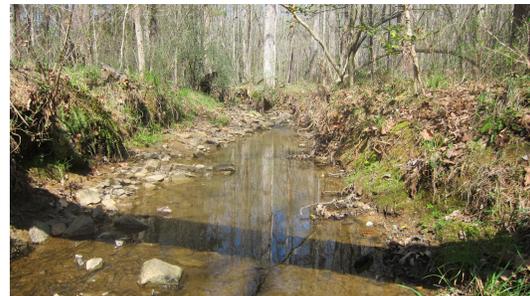
Jolly Branch, April 2013.

Jolly Branch near SR 1777 (just downstream of Bolin Creek 3). This site was accessed by walking about 100 meters downstream of SR 1777 (Homestead), crossing Bolin Creek, and going about 30 meters upstream on Jolly Branch. This small stream (1 meter wide) had good rocky habitat, but showed severe bank erosion in many places.

The surrounding area was largely forested, although there are residential areas further upstream. The aquatic life at Jolly Branch indicates that it may stop flowing (or go dry) during drought periods.
