**BIOLOGICAL MONITORING OF
BOLIN CREEK AND TRIBUTARIES,
CARRBORO, NORTH CAROLINA
April-June 2015**

**LENAT CONSULTING SERVICES
3607 CORBIN STREET
RALEIGH, NC 27612
919-787-8087
LENATBKS@MINDSPRING.COM**

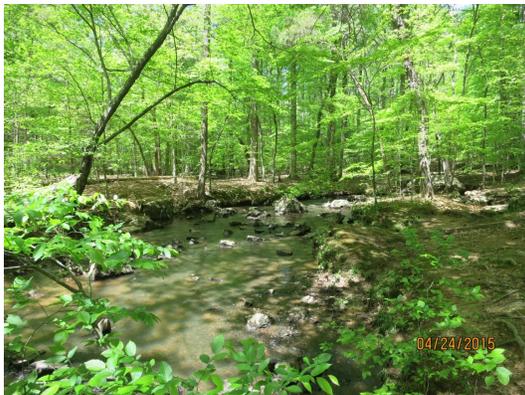
Bolin Creek Site 1, April 2015.

This part of Bolin Creek averaged about 4-5 meters wide, with a substrate mainly composed of gravel and rubble. Both the substrate composition and the width, however, were highly variable. There were no significant habitat problems in this section of Bolin Creek, although 2015 samples suggest some water quality problems.

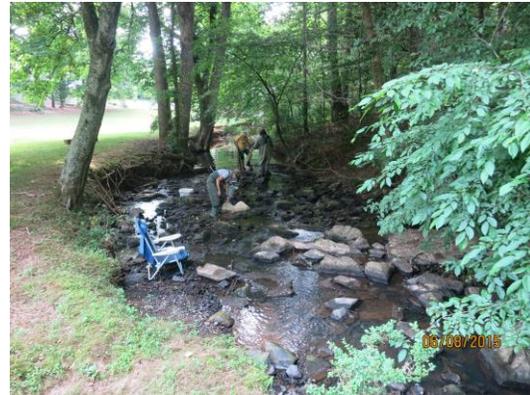
Bolin Creek Site 2, June 2015.

Bolin Creek 2. Site 2 is located downstream of the Winmore development at SR 1777. There is private residence on one side of the stream that lacks a buffer zone. Consequently, there is significant bank erosion on one side of the stream.

Habitat problems included fewer riffles, bank erosion, lack of a buffer on one side and a decrease in habitat diversity. A beaver had been present in the upstream segment, but had been removed in 2015.

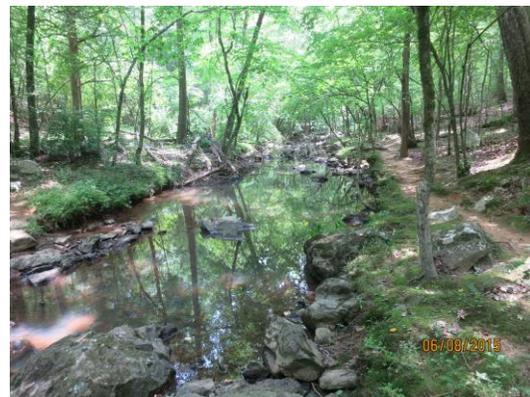
Bolin Creek Site 3, June 2015.

There are no significant habitat problems in this portion of the stream, but there was a lack of good bank habitat.

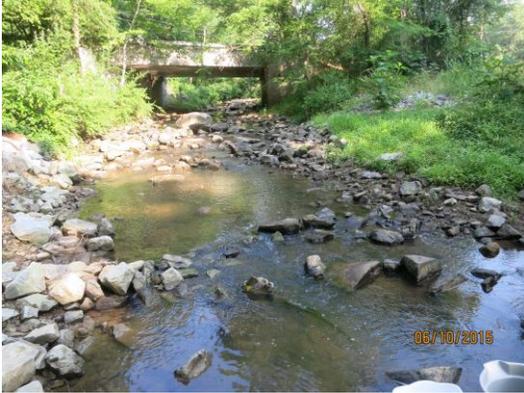
Bolin Creek Site 4, April 2015.

This portion of Bolin Creek is similar to the site on Estes Drive, having good rocky substrate. Attached filamentous algae was very abundant at the Village Drive site in March 2011, but was not a problem in later years.

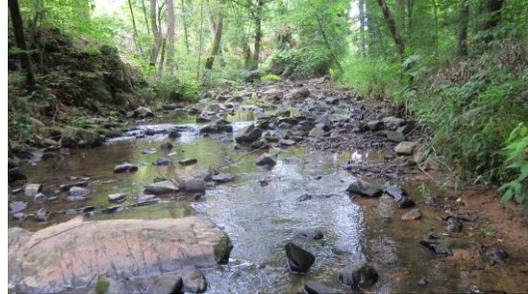
Morgan Creek, NC 54, June 2012.

This catchment has a largely rural character, with some minor impacts from nonpoint source runoff. Habitat quality, stream width and substrate composition are similar to Bolin Creek, but with less residential land use. Residential land use, however, has been increasing in the Morgan Creek catchment in recent years.

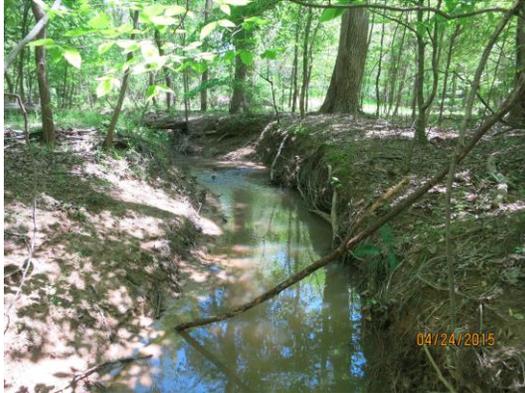
UT Bolin Creek 1, April 2015

This small tributary flows through a largely residential area, although the area near the confluence with Bolin Creek is forested. It is a sandy stream with gravel riffles.

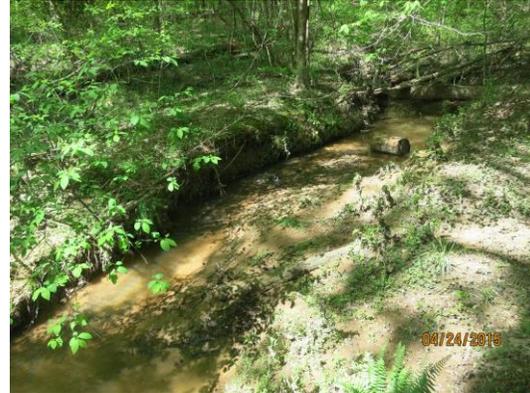
UT Bolin Creek 2, April 2015

The small tributary stream drains an area of mixed residential and forested land use. It has a sand and gravel substrate, with some rubble in riffle areas.
