Appendix 3. Carrboro Stream Sites, April-June 2013

Bolin Creek sites are numbered from most upstream (Site 1) to most downstream (Site 4). Samples from Bolin Creek and Morgan Creek were collected in June 2013; tributary sites were sampled in April 2013.

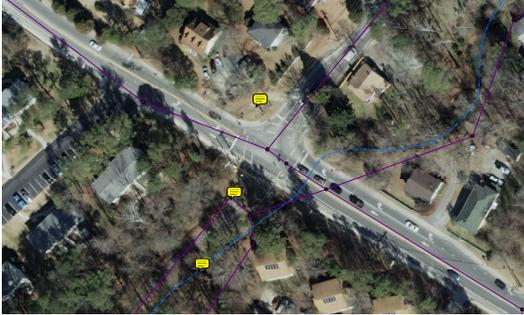
UT Bolin Creek, aerial view.

UT Bolin Creek, intersection of Greensboro Rd and Estes Drive Extension. This very small stream is likely to be intermittent, requiring that samples be taken in winter or spring.
